HDP3 & HDP4 loose fitment

Date: 11.02.2020

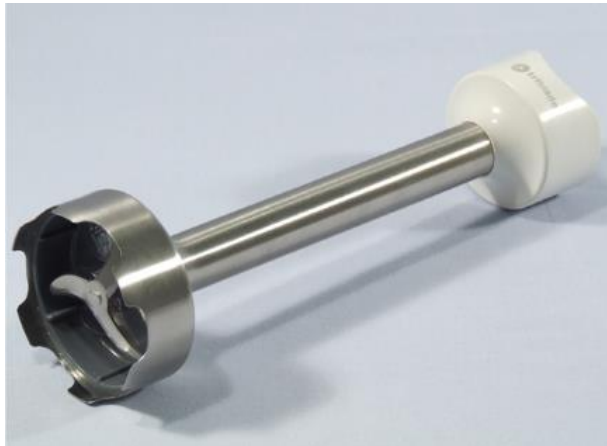
Metal Wand KW712960

Description: There were reports from the field the HDP3/HDP4 metal wand and chopper lid may de-latch when assembled to power unit.

Root cause: Due to the moulding process not being controlled the metal wand and chopper lid may be out of tolerance.

Solution: If reported, the Metal Wand (KW712960) or Chopper Lid (KW712996) must be replaced. Metal Wand and Chopper lid spare parts held in stock are correct. The finished goods manufactured after date code **19S50** are good.

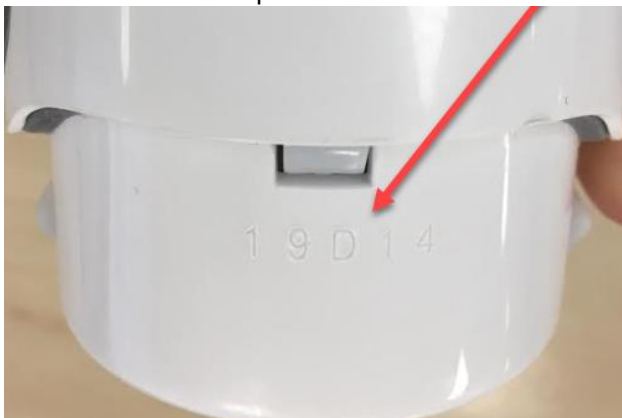
The power handle:

Identification: The affected date codes are **19D17 – 19J28**. The date codes can be found on:
